REPORT OF INVESTIGATION

Surface Coal Mine

Fatal Machinery Accident
March 12, 2007

Double E Augering Inc.
No. 3
Feds Creek, Pike County, Kentucky
I.D. No. 15-18940

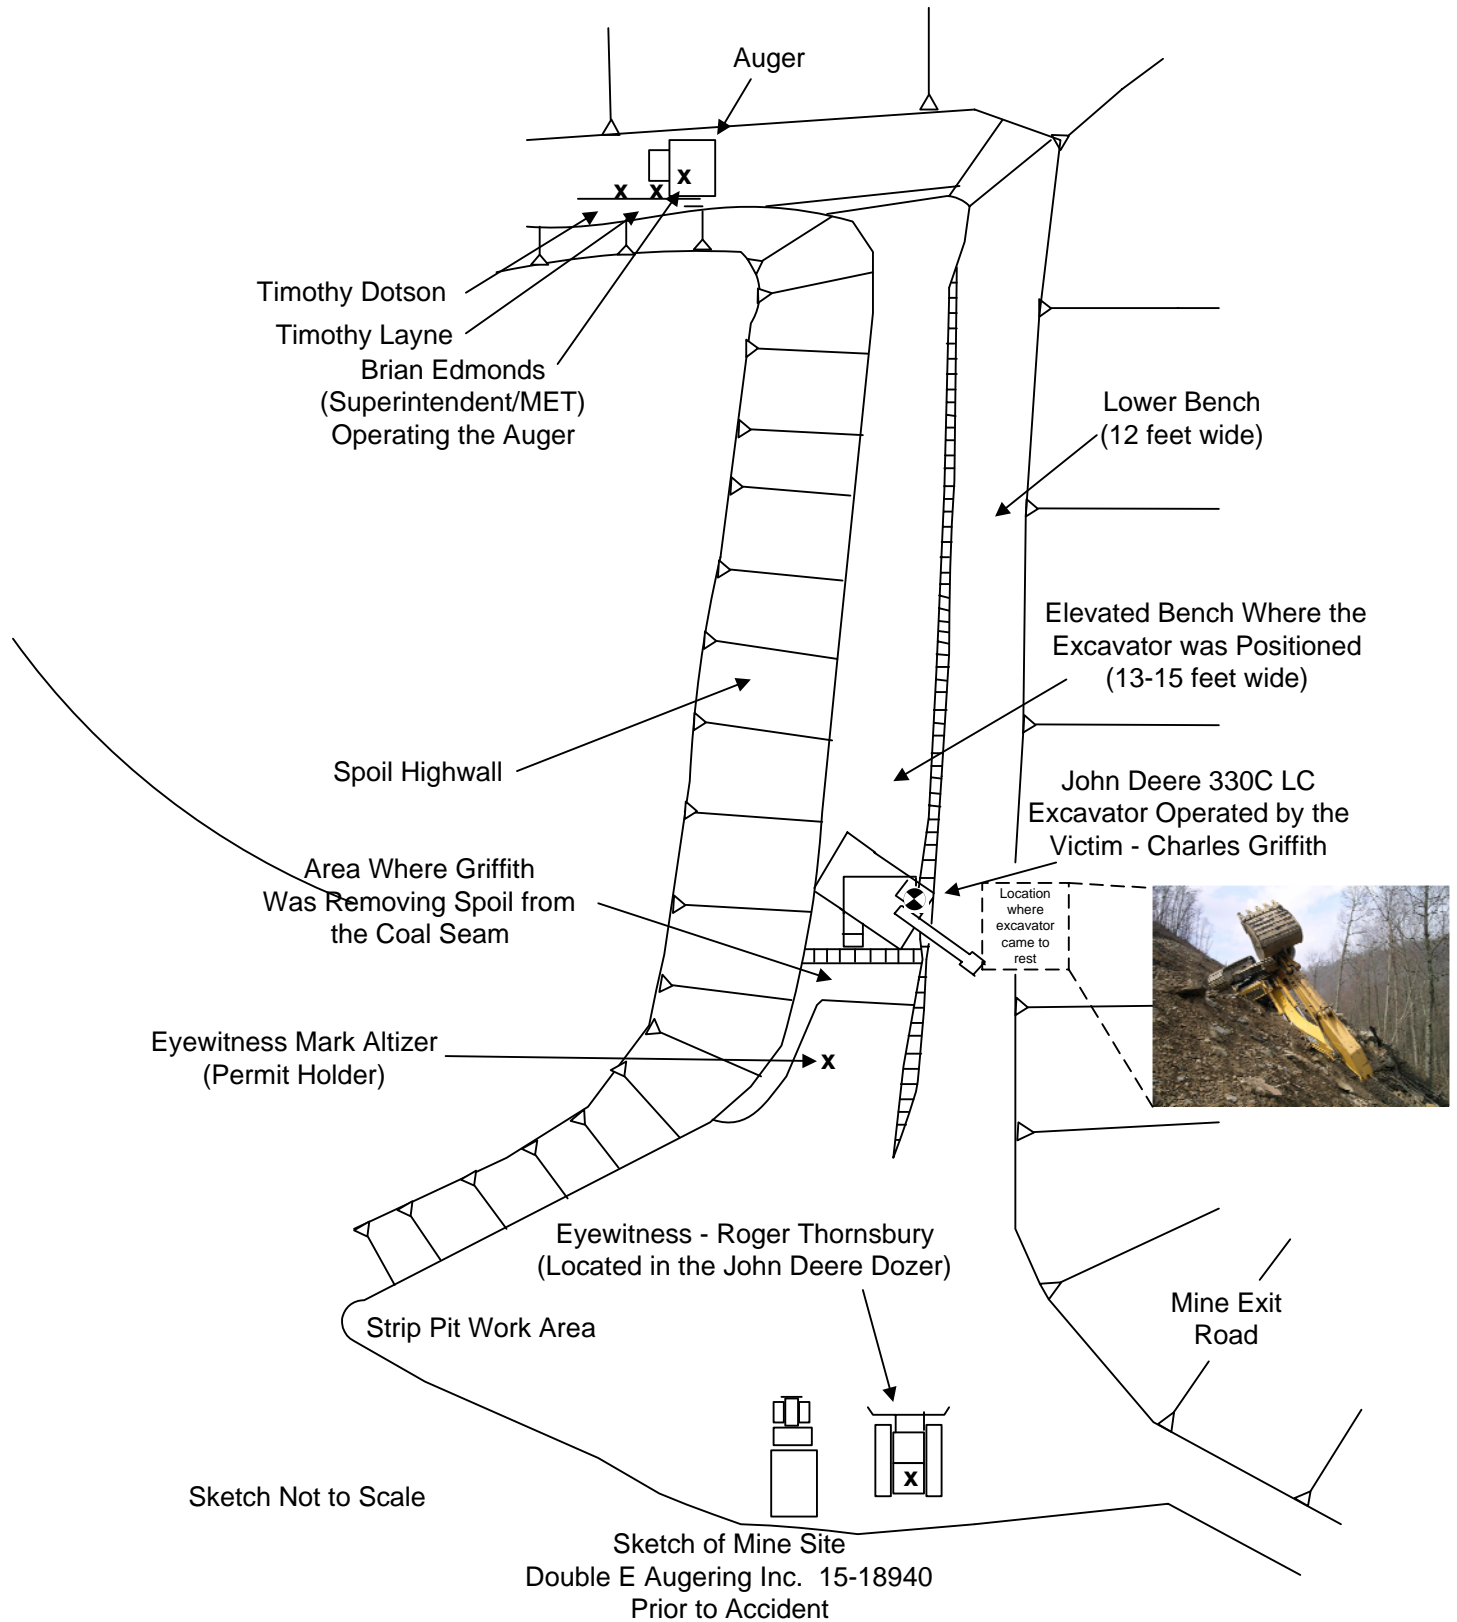
The accident occurred because the width of the elevated mine bench was not sufficient to insure safe operation of the excavator.

The accident occurred because safe conditions for operating the excavator on an elevated mine bench were not provided. The width of the bench was not sufficient to insure safe operation of the excavator. The upper mine bench was measured to be 13 feet wide and the excavator tracks were 11 feet, 2 inches wide. The excavator was being operated on the edge of the bench in order to allow rotation of the deck.

Photo showing upper and lower benches

Corrective actions: The mine operator developed a plan to prevent a similar occurrence of this accident. The ground control plan was revised to show when track-mounted equipment is being operated parallel to the outslope from an elevated bench on in-place shot material, the width of the bench will be a minimum of 1.5 times wider than the distance between the outside edges of the equipment tracks. The plan also requires training to be provided to the employees concerning the revised ground control plan and hazards associated with operating equipment from a mine bench.
